San Juan Initiative Protection Assessment Nearshore Case Study Area Characterization

Prepared for:
The San Juan Initiative; The Puget Sound Partnership
through The Surfrider Foundation

Prepared by:
Coastal Geologic Services Inc.
Andrea MacLennan, MS and
Jim Johannessen, MS and LEG

June 9, 2008

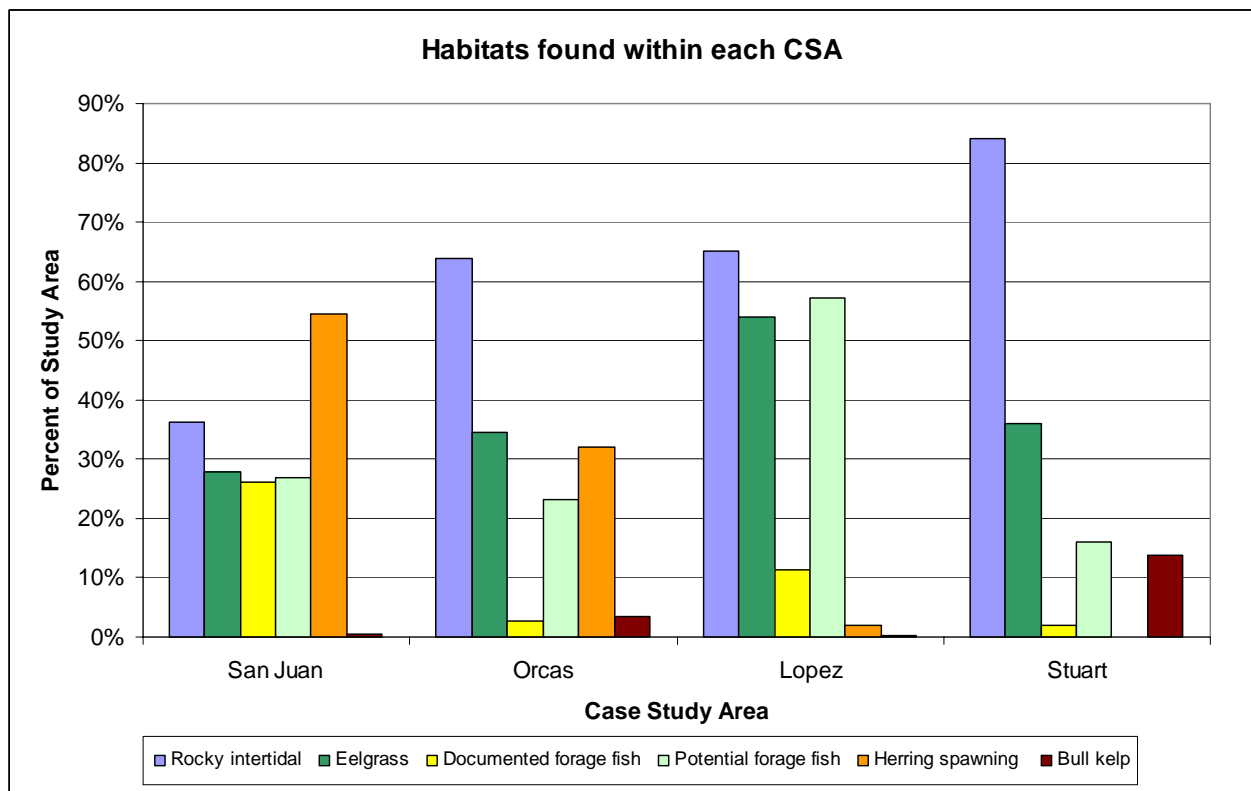
Figure 1. Percent of each CSA (shoreline length) that each habitat of interest encompassed. Habitats of interest include: Rocky intertidal habitat (indicated by *Fucus sp.*, WDNR, 2001), Eelgrass outer-line (FSJ et. al., 2004), Documented forage fish spawning habitat (WDFW, 2004), Potential forage fish spawning habitat (Moulton and Penttila, 2001), Herring spawning habitat (WDFW, 2004), Bull kelp (FSJ & WDNR, 2007).

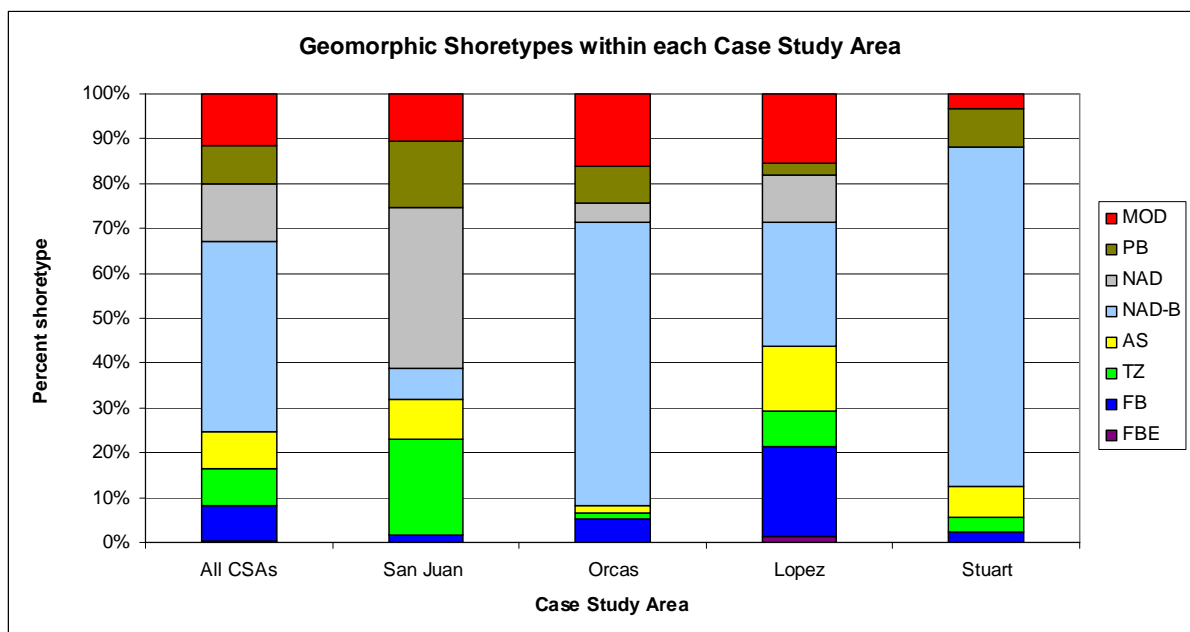
Figure 2. Geomorphic shoretypes mapped within each CSA. MOD = Modified shore, PB = Pocket Beach, NAD = No Appreciable Drift, NAD-B = Bedrock shore, AS = Accretion Shoreform, TZ = Transport Zone, FB = Feeder Bluff, FBE = Feeder Bluff Exceptional.

The contrasting geomorphic conditions of each CSA combined with the variable parcel densities likely influenced these results (Table 8, Figure 2). For example the Lopez case study area was comprised of a much greater percent of feeder bluff, transport zones and accretion shoreforms, which support the processes that create and maintain forage fish habitats and eelgrass beds. Analyses by Dr. M. Dethier showed a positive correlation between potential forage fish spawning habitat and feeder bluffs (Appendix 3). Stuart and Orcas Island CSAs had far more bedrock shores and therefore support more rocky intertidal and bull kelp than other CSAs, as well as a considerable amount of eelgrass (Figures 1 and 2). The Lopez Island case study area also had bedrock shores that support rocky intertidal habitats, though this shoretype was limited to the northern extent of the study area. The San Juan Island CSA was comprised of a larger portion of pocket beaches and areas of No Appreciable Drift. Throughout all CSAs, feeder bluffs (exceptional and regular), accretion shoreforms, transport zones and pocket beaches each represented (exceeded approximately 8- 8.5% of the shore. Bedrock shores

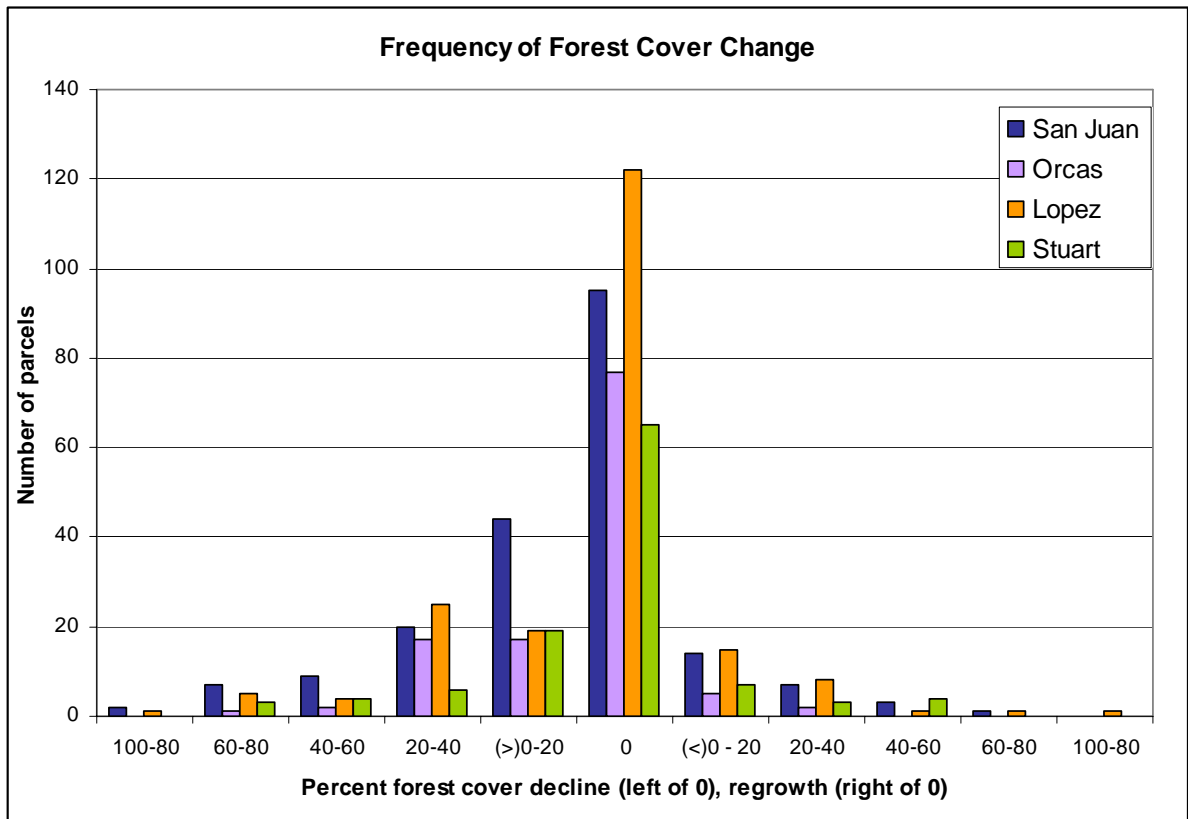
Figure 6. Frequency of forest cover change, showing percent forest cover decline (left of zero) and forest cover re-growth (right of zero) among the parcels assessed in each CSA.

Overall, forest cover decline was observed within 32% of all parcels assessed. Fifty-six percent of the parcels had no forest change and 11% of the parcels showed an increase in forest cover during the period of assessment, from 1977 – 2006 (Figure 6). The high variability of these data likely reflects the interaction of the natural and anthropogenic causative factors in combination with the variable interpretation and implementation of the current management tools used in an attempt to retain riparian vegetation along waterfront properties.

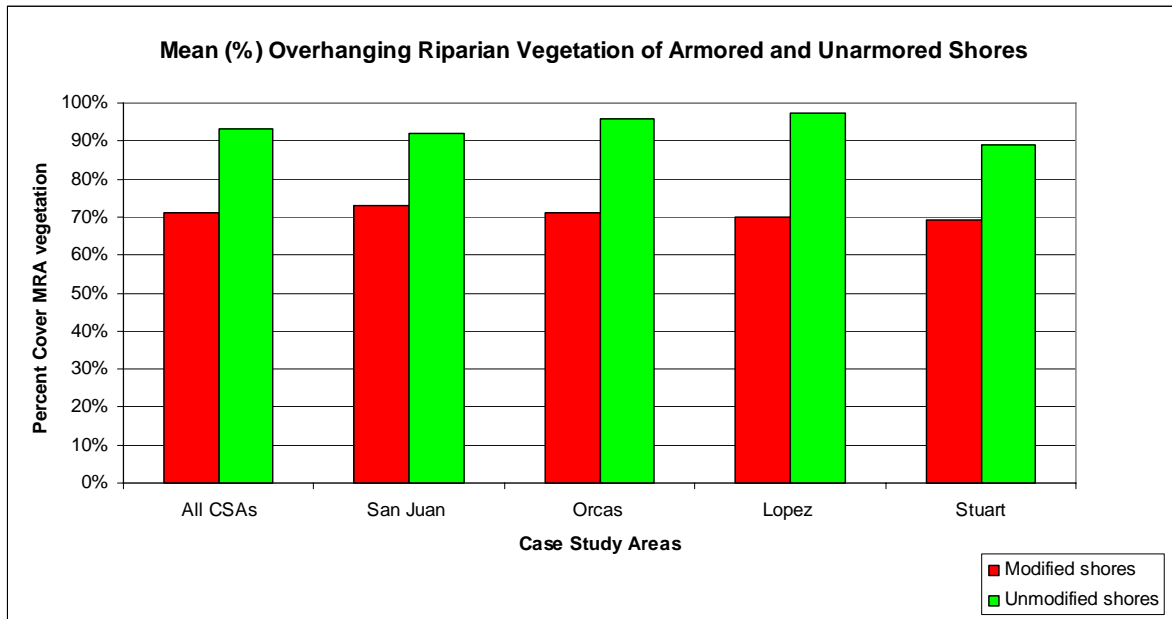
Figure 7. Mean percent overhanging marine riparian vegetation (all vegetation classes summed) of armored and unarmored shores as observed in 2006.

Further analyses of the marine riparian vegetation data included exploring the relationship between modified (armored) shores and the occurrence of marine riparian vegetation (both overhanging and aerial extent/cover). The presence of shore modifications (predominantly shore armoring) appeared to have an effect on the quantity of overhanging marine riparian vegetation. Data showed that modified shores had 19 – 27% less overhanging riparian vegetation than unmodified shores (Table 14, Figure 7). This trend was most apparent on Lopez Island, followed by the Orcas Island case study area. A similar, although less dramatic, relationship was observed between overhanging forest vegetation along armored as compared to unarmored shores (Table 15).

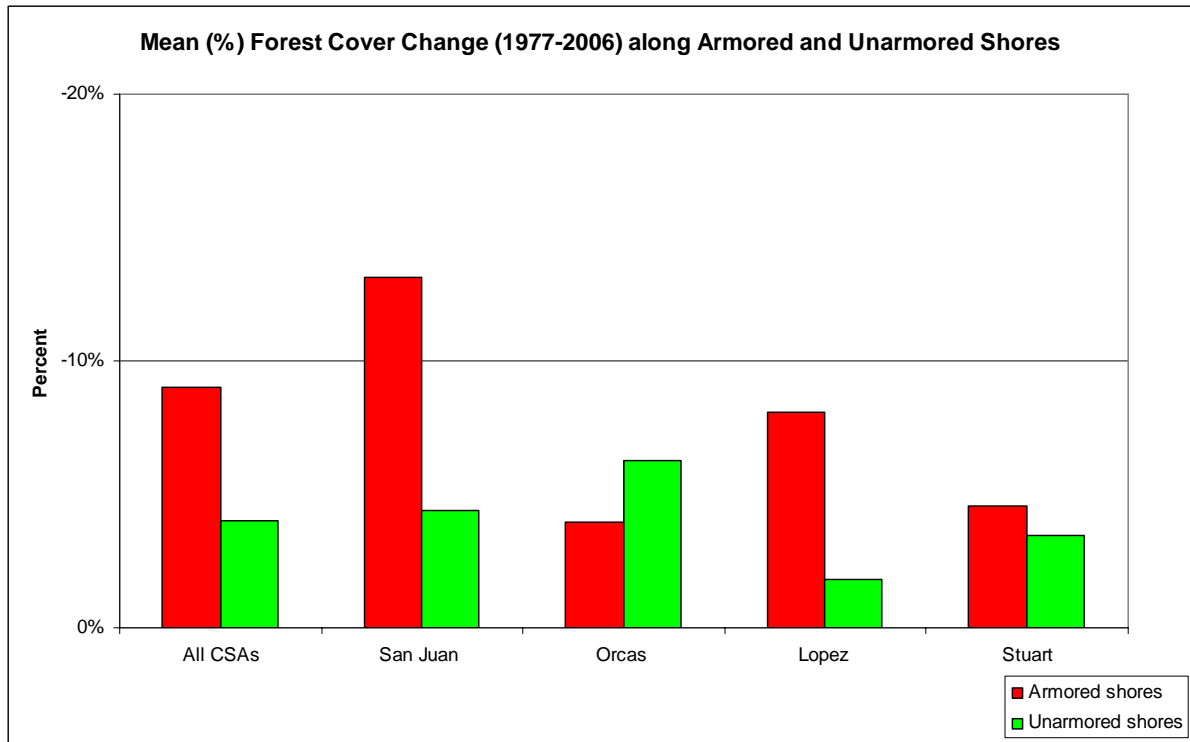
Figure 9. Mean marine riparian forest cover change from 1977 – 2006 along armored and unarmored shores. Negative value indicates decrease in forest cover.

Shore modifications were also associated with a greater average decline in forest cover over the period of analysis (1977 - 2006). This pattern was most evident within the San Juan and Lopez Island CSAs (Table 17, Figure 9). It was far less apparent on Orcas Island where unmodified shores also incurred substantial (average) declines in forest cover. The large range of the data is indicative of the large variability in forest cover change that occurred across all parcels throughout the study area. This variability likely decreased the apparent strength of this relationship, as all change measures were averaged, rather than only those showing a decline in forest cover.

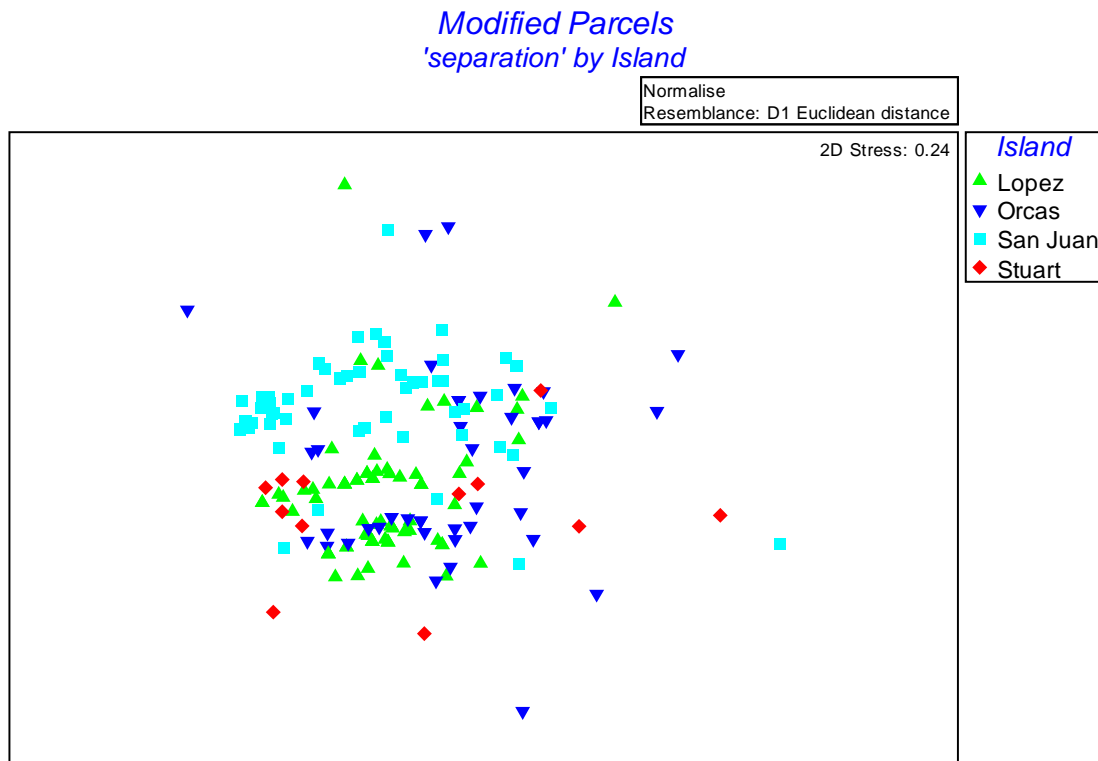
When these data are recoded to show the island of each parcel, a weak clustering can again be seen; this grouping is statistically stronger than the grouping by dock presence/absence ($R = .337$). Modified parcels on Orcas tend to be in areas with pocket beaches or rocky shores, and are on larger and wider lots that those on San Juan. Modified parcels on San Juan tend to be on accretionary beaches or no-net-drift beaches. These weak patterns may simply relate to the exact shorelines used in the analyses, and are probably not subject to detailed interpretation.
